October 1, 2020

Subject: Asbestos Assessment
Peabody Elementary School
425 C St NE,
Washington, DC 20002

Photo Log

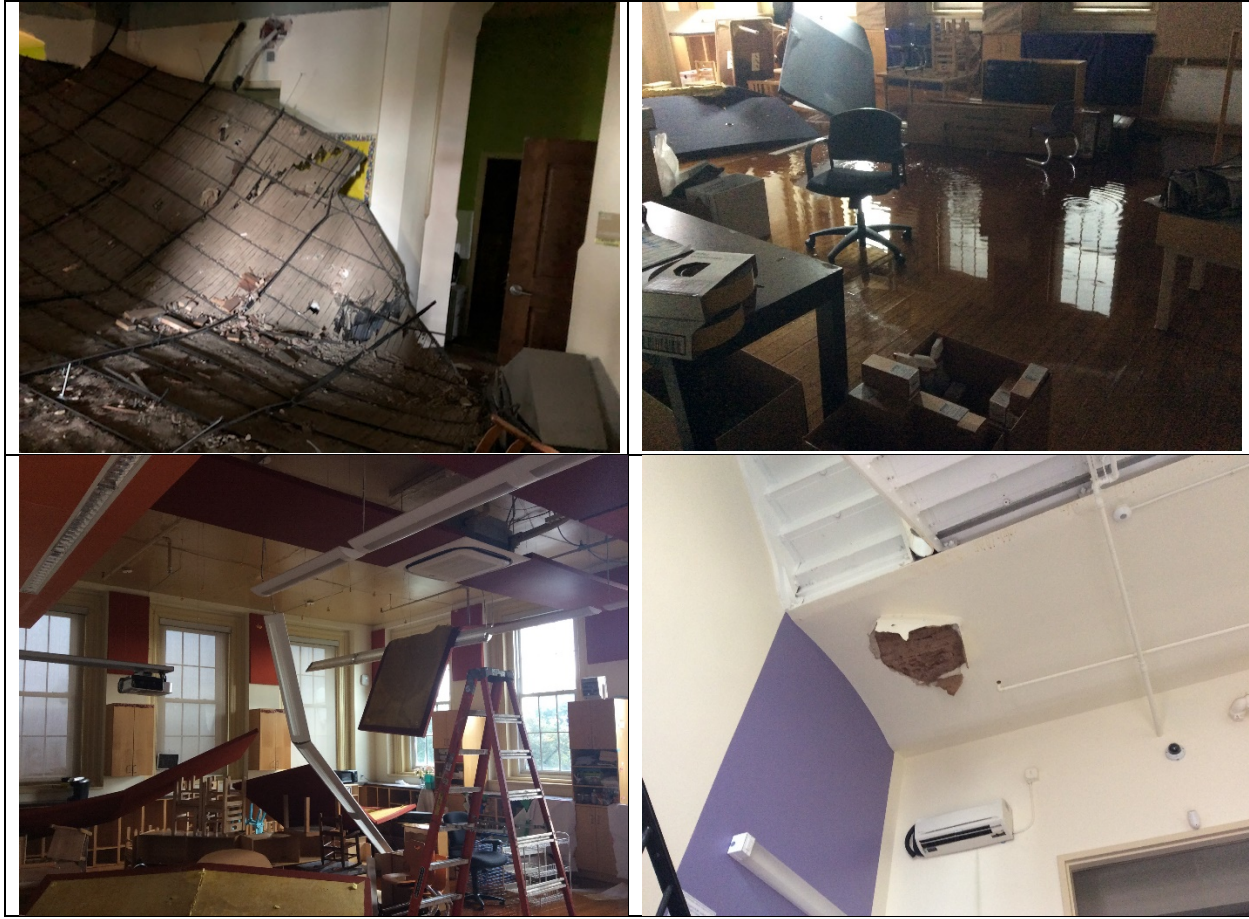
The material affected and damaged during the flooding were plaster ceiling and brown coating which were cross-referenced to the school’s Asbestos Management Plan and confirmed the material does not contain asbestos. Table 1 provides a summary of the material identified during the inspection and their asbestos status according to the AMP.

Peabody Elementary School, 3rd Floor Ceiling Damage (Sept. 28, 2020)

Following these findings, the Inspector cleared the area for safe repairs and cleanup by the contractors.
